Test Report

A 9026-1 / 2011

Contract : Testing of the gas tightness of the ring sealing
HSD 100-SSG-18-65 for building entries with
compressed air at a test temperature of 23 °C

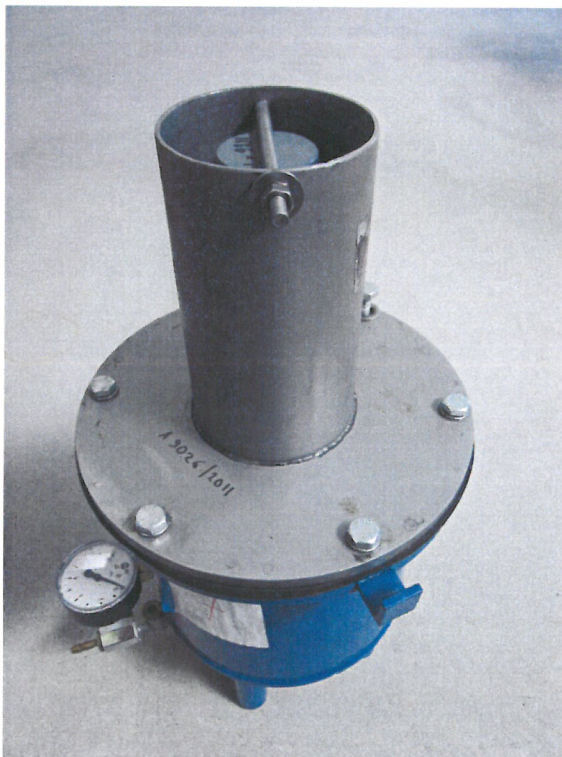
Figure 1: Test setup

The ring sealing system HSD 100-SSG-18-65 was installed in a testing cylinder as shown in Figure 1 and Figure 3. The used sealing insert was assembled with one dummy plug Ø 45 mm.

The test member which was delivered by the Manufacturer was a pre-assembled test member with a test setup in accordance with section 2.1 and with a pre-assembled manometer (see Figure 1 and Figure 3). A calibration of the manometer by Kiwa MPA Bautest GmbH was not carried out.

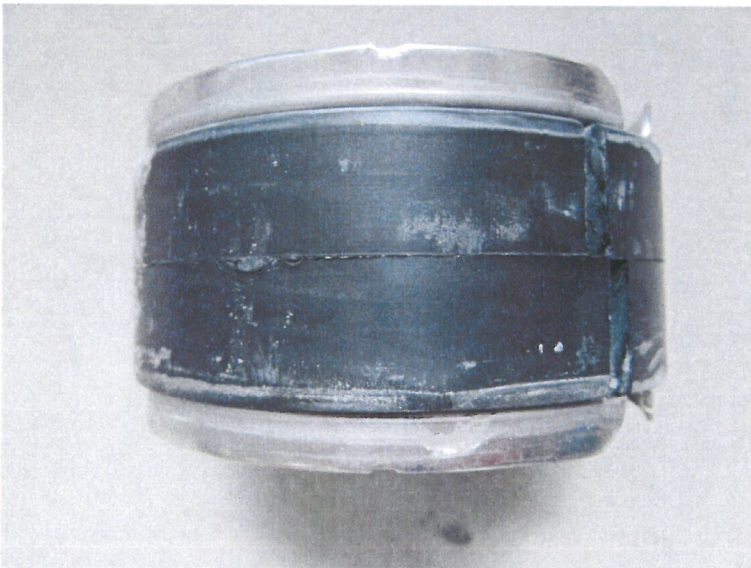
Figure 2: Ring sealing HSD 100-SSG-18-65

The ring sealing system HSD 100-SSG-18-65 is a divided seal insert with an insert for one cable for use as a cable lead-through for buildings with an existing casing or core hole of Ø 102 mm. HSD 100-SSG-18-65 is a sealing insert of rubber EPDM with a sealing width of 40 mm.

After consultation with the Manufacturer a tightness test with compressed air over a period of 24 h with a nominal pressure of 5 bar and a test temperature of 23 °C was carried out with a test specimen as shown in Figure 2.

Subsequent a second tightness test with compressed air over a period of 24 h with a nominal pressure of 6 bar and a test temperature of 23 °C was carried out with a test specimen as shown in Figure 2.

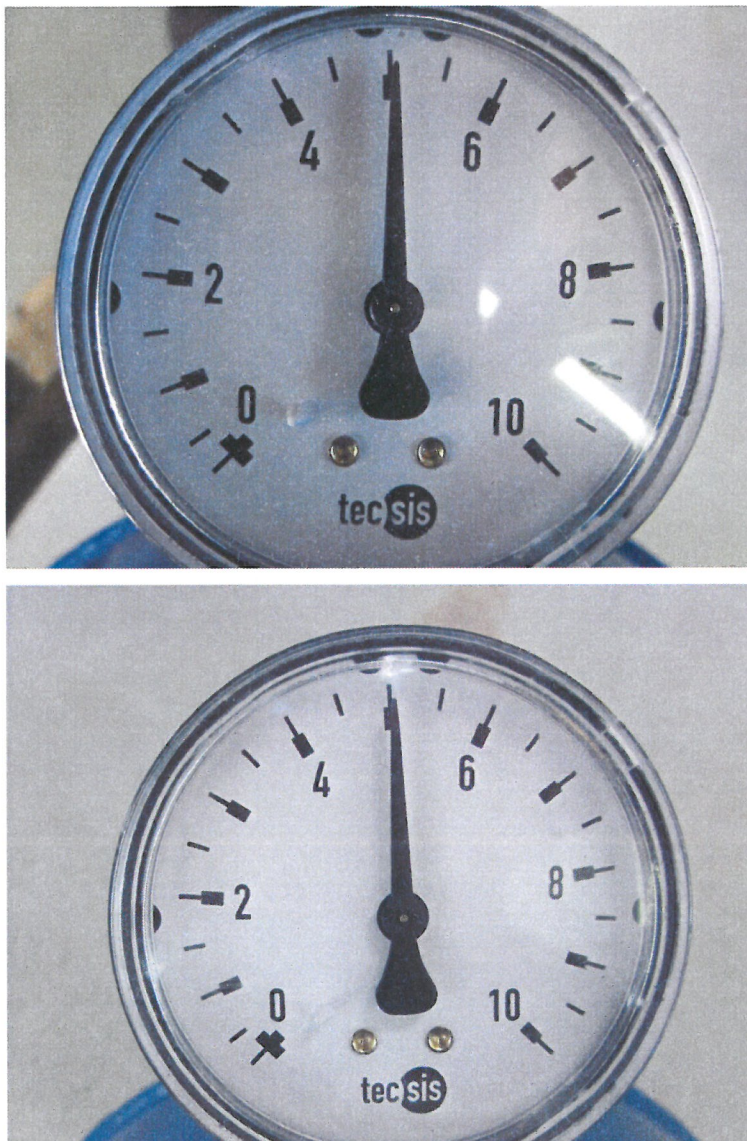
Figure 4: Tightness test with compressed air (5 bar) filled pressure bell at 23 °C (above: manometer display at the beginning of the test at 04/18/2011 07:45; below: manometer display at the end of the test at 04/19/2011 10:10)

Subsequent in Figure 4 to Figure 5 the manometer display at the beginning and at the end of the tightness tests are shown.

During the tightness tests of the ring sealing system HSD 100-SSG-18-65 at a test temperature of 23 °C with compressed air filled pressure bell with nominal pressure of 5 bar and 6 bar respectively over the respective test period of 24 h no defect could be detected.

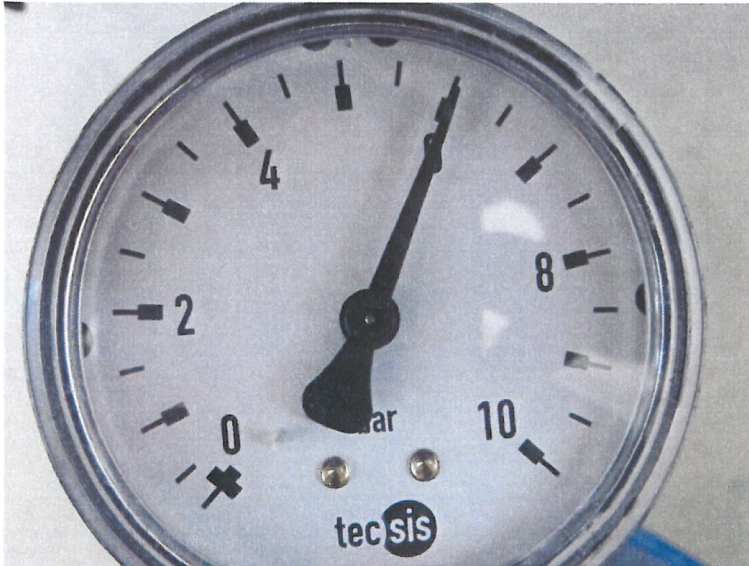
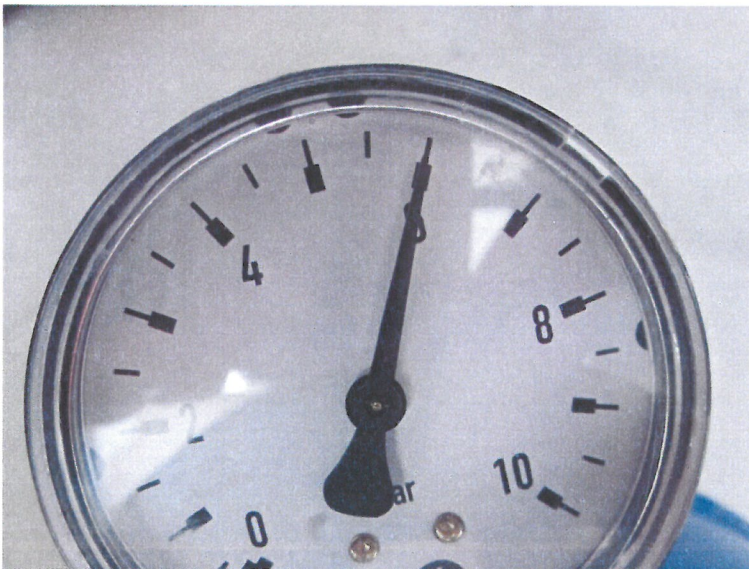
Figure 5: Tightness test with compressed air (6 bar) filled pressure bell at 23 °C (above: manometer display at the beginning of the test at 04/19/2011 11:30; below: manometer display at the end of the test at 04/20/2011 11:30)
